17-year-old Warehouse Worker Crushed by Forklift

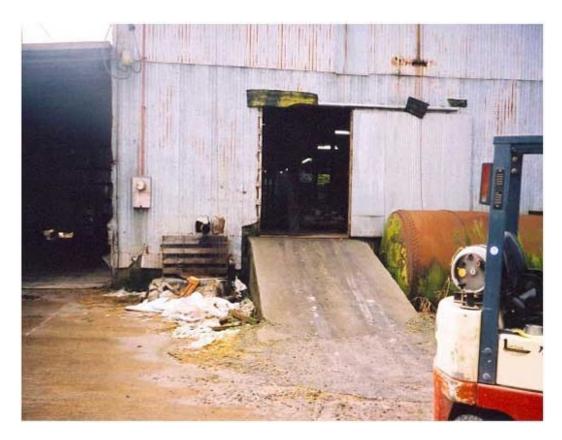
Photo 1

The incident happened at an agricultural cooperative (co-op). The co-op's retail store was connected to the co-op's tire shop and a warehouse. Also, on the grounds was an equipment storage shed, a fertilizer shed, and an outdoor storage area where 200-pound molasses animal licks were stored. A large flat concrete parking lot extended in front of the store entrance and around one side of the warehouse where a loading dock and ramp were located — Photo 1.

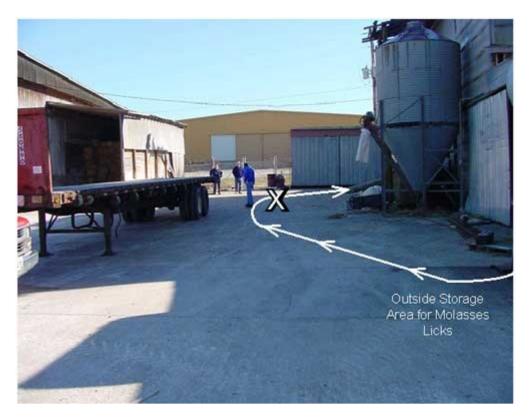
It appeared the victim was traveling toward the warehouse ramp on the level surface of the parking lot and made a sharp right turn to enter the narrow ramp leading up to the warehouse. It is surmised this is when the forklift tipped over onto its left side. The forklift was not loaded but its forks were raised approximately 20 inches. There was a single 12-foot skid mark located on the parking lot where it is surmised the victim started into a right turn toward the ramp.

Photo 2 illustrates the parking lot, warehouse and ramp, and other co-op buildings. Lines on the photo approximate the travel path of the forklift on the day of the incident. An "X" marks the approximate location of the forklift that had tipped over. Photograph courtesy of the Tennessee Department of Labor and Workforce Development, Division of Occupational Safety and Health.

The entrance/exit of the warehouse was narrow, measuring 70 inches in width. A post and an abandoned grain feed dispersal bin located inside the entrance left just enough room for the forklift to pass through.

- Old scrape marks on the forklift and on the post and grain bin inside the warehouse were likely indicators of a tight fit.
- The local manager said that forklift operators had to speed up to make it up the ramp and then had to slow down at the entrance to fit through the narrow passage after passing through the warehouse door.
- The ramp's surface was patched and rough where the ramp joined the flat, level parking lot.
 - The co-op was being relocated so the rough pavement in the transitional area where the level parking lot met the ramp, and the confined areas in the warehouse had not been changed because of the planned move.
 - It is worth noting these issues were known and identified as problematic.
- A well-developed safety and training program were lacking.

- Conduct periodic inspections and frequently remind equipment operators to use seat belts provided and never try to jump from an overturning sit-down type forklift.

- Check travel routes used by forklifts are free of obstacles and other unsafe conditions.
- Establish work policies that comply with child labor laws prohibiting youths less than 18 years of age from performing hazardous work, including operating power-driven hoisting equipment such as forklifts. All employees should be aware of this policy.
