# 17-year-old Warehouse Worker Crushed by Forklift

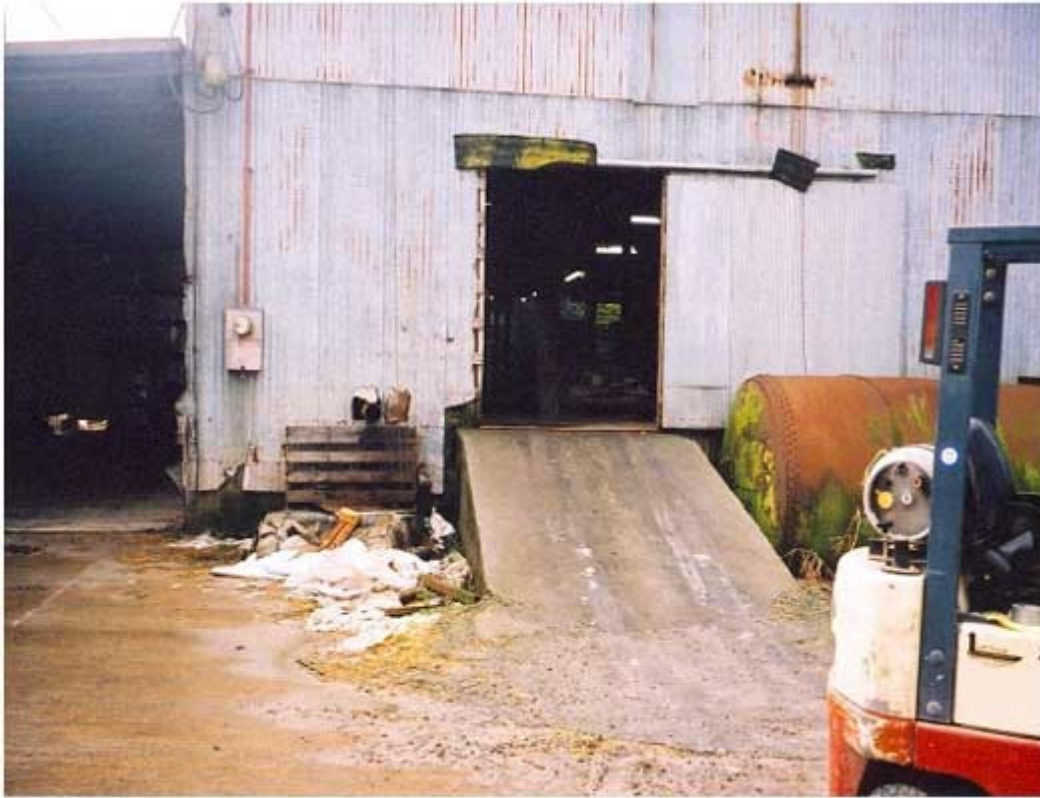
**Photo 1**

The incident happened at an agricultural cooperative (co-op). The co-op's retail store was connected to the co-op's tire shop and a warehouse. Also, on the grounds was an equipment storage shed, a fertilizer shed, and an outdoor storage area where 200-pound molasses animal licks were stored. A large flat concrete parking lot extended in front of the store entrance and around one side of the warehouse where a loading dock and ramp were located – Photo 1.

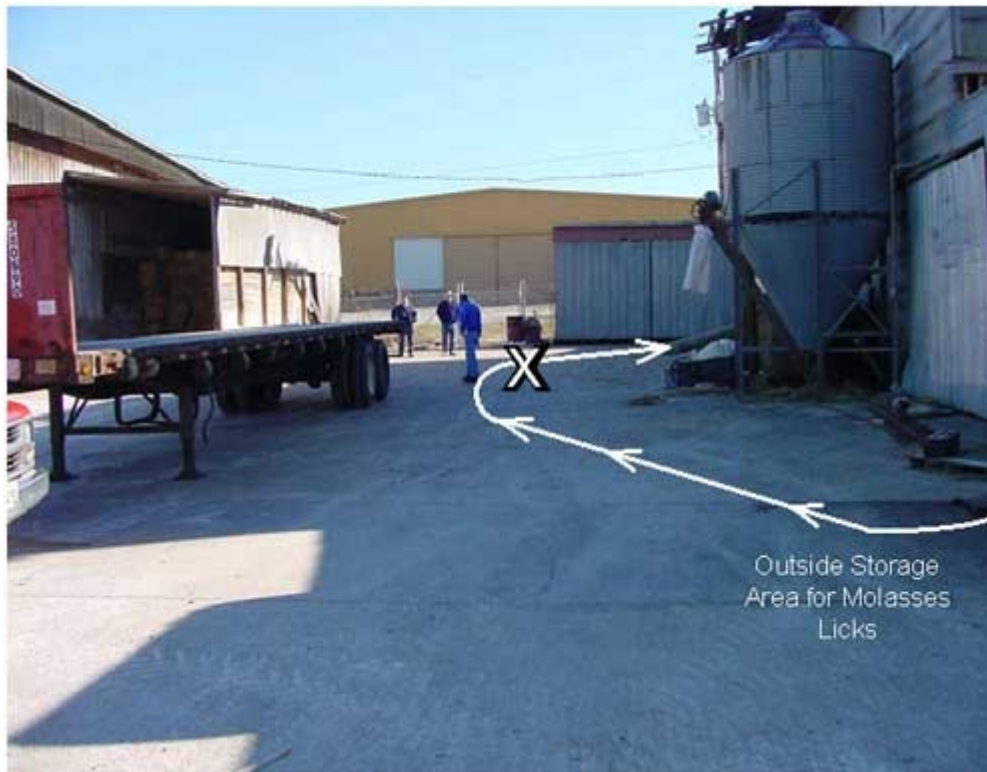
**Photo 2**

It appeared the victim was traveling toward the warehouse ramp on the level surface of the parking lot and made a sharp right turn to enter the narrow ramp leading up to the warehouse. It is surmised this is when the forklift tipped over onto its left side. The forklift was not loaded but its forks were raised approximately 20 inches. There was a single 12-foot skid mark located on the parking lot where it is surmised the victim started into a right turn toward the ramp.

Photo 2 illustrates the parking lot, warehouse and ramp, and other co-op buildings. Lines on the photo approximate the travel path of the forklift on the day of the incident. An "X" marks the approximate location of the forklift that had tipped over. Photograph courtesy of the Tennessee Department of Labor and Workforce Development, Division of Occupational Safety and Health.

- Conduct periodic inspections and frequently remind equipment operators to use seat belts provided and never try to jump from an overturning sit-down type forklift.

- Check travel routes used by forklifts are free of obstacles and other unsafe conditions.
- Establish work policies that comply with child labor laws prohibiting youths less than 18 years of age from performing hazardous work, including operating power-driven hoisting equipment such as forklifts. All employees should be aware of this policy.
