## Crushed-between Scissor Lift and Support Beam

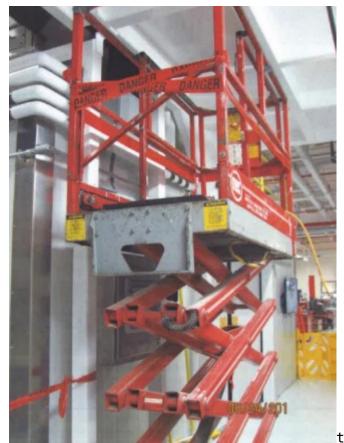
At some point while installing the insulation the victim became pinned between

the scissor lift upper guard rail and bottom of the mezzanine outer support beam. During the investigation, it was determined that the control console on the scissor lift was missing the guard that prevents the inadvertent activation of the lowering and rising of the work platform.

The control console was found hanging on the opposite side of the lift from the victim's work position. The most likely scenario is that the victim contacted the unguarded control console with his foot while trying to position himself leaning backwards out of the lift.

Had the guard been in place on the control panel and the victim not been working alone, it is likely this incident would have had a much different outcome. However, during the inspection it also was found the lower controls on the lift were not functioning, so it's possible that even if someone else was present they may not have been able to move the lift and free the victim in time.

This incident also highlights the importance of preventative maintenance and removing damaged or defective equipment from service until they are repaired or replaced.
