# Crushed-between Scissor Lift and Support Beam

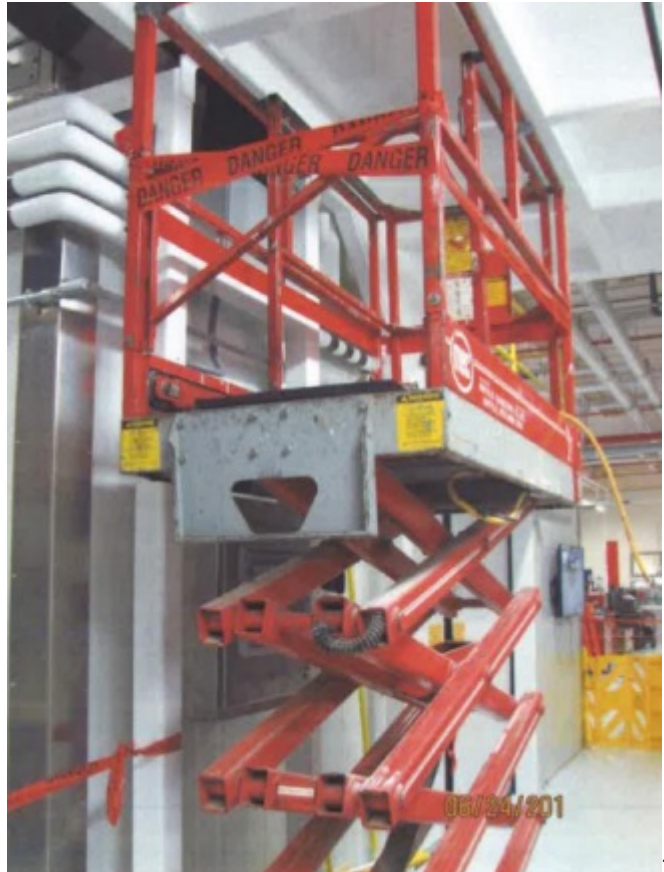
At some point while installing the insulation the victim became pinned between

the scissor lift upper guard rail and the bottom of the mezzanine outer support beam. During the investigation, it was determined that the control console on the scissor lift was missing the guard that prevents the inadvertent activation of the lowering and rising of the work platform.

The control console was found hanging on the opposite side of the lift from the victim's work position. The most likely scenario is that the victim contacted the unguarded control console with his foot while trying to position himself leaning backwards out of the lift.

Had the guard been in place on the control panel and the victim not been working alone, it is likely this incident would have had a much different outcome. However, during the inspection it also was found the lower controls on the lift were not functioning, so it's possible that even if someone else was present they may not have been able to move the lift and free the victim in time.

This incident also highlights the importance of preventative maintenance and removing damaged or defective equipment from service until they are repaired or replaced.
