# Warehouse Supervisor Crushed by Pallet Stacking Machine

A 40-year-old experienced warehouse supervisor died when he was struck by a pallet stacking machine and crushed against a storage rack support.

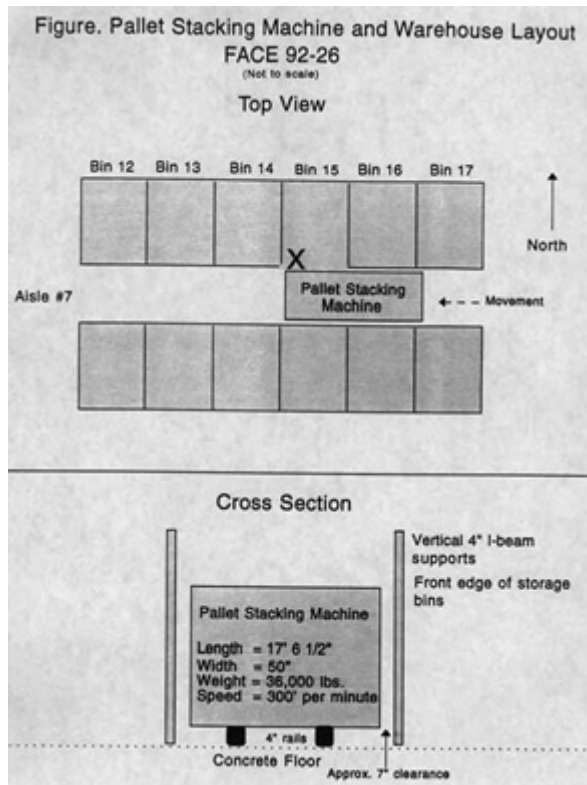
The clearance between the storage bins' vertical 4-inch I-beam supports and the stacking machine's metal frame was approximately 7 inches. The stacking machine was approximately 17-feet 6-inches long by 50-inches wide and weighed 36,000 pounds. The travel speed was about 300-feet per minute or 3½-miles per hour as it traveled in an east and west direction between the storage bins.

For unknown reasons the victim was in the aisle and had his back to the approaching stacking machine. It struck and crushed him between the stacking machine's frame and the storage rack's vertical support I-beam. His body was dragged several feet until some part of the victim's body contacted the bumper, causing the machine to stop.

- Creation of specific procedures to follow prior to any work being performed in the aisles. Including:
  - Locking and tagging the machine in the off position when personnel are in the aisles.
  - Retaining the key until all work is completed and the aisles are clear of personnel.
- Consider using two workers to perform any work in the aisles. One worker

- Installation of stationary travel warning lights at conspicuous areas within the aisles.
  - Any time the machine is in operation, the stationary travel warning lights would illuminate to warn any worker in the area that the machine is in operation and to be alert to its location and movement.
- Redesigning the pressure-sensitive stop bumpers so an object located laterally, or adjacent to the machine, would contact the bumper causing it to stop.
  - The pressure-sensitive stop bumpers located on the front and rear ends of the machine, could only be activated by direct forward or rearward pressure on the bumpers.
  - An object which was positioned laterally, or adjacent to the direct line of travel (as was the case in this incident), would not engage the bumpers and stop the machine.
