# Warehouse Supervisor Crushed by Pallet Stacking Machine

A 40-year-old experienced warehouse supervisor died when he was struck by a pallet stacking machine and crushed against a storage rack support.

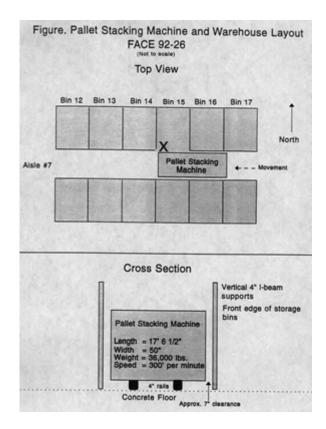
The clearance between the storage bins' vertical 4-inch I-beam supports and the stacking machine's metal frame was approximately 7 inches. The stacking machine was approximately 17-feet 6-inches long by 50-inches wide and weighed 36,000 pounds. The travel speed was about 300-feet per minute or  $3\frac{1}{2}$ -miles per hour as it traveled in an east and west direction between the storage bins.

For unknown reasons the victim was in the aisle and had his back to the approaching stacking machine. It struck and crushed him between the stacking machine's frame and the storage rack's vertical support I-beam. His body was dragged several feet until some part of the victim's body contacted the bumper, causing the machine to stop.

- Creation of specific procedures to follow prior to any work being performed in the aisles. Including:
  - $\circ$  Locking and tagging the machine in the off position when personnel are in the aisles.
  - Retaining the key until all work is completed and the aisles are clear of personnel.
- Consider using two workers to perform any work in the aisles. One worker

- Installation of stationary travel warning lights at conspicuous areas within the aisles.
  - Any time the machine is in operation, the stationary travel warning lights would illuminate to warn any worker in the area that the machine is in operation and to be alert to its location and movement.
- Redesigning the pressure-sensitive stop bumpers so an object located laterally, or adjacent to the machine, would contact the bumper causing it to stop.
  - The pressure-sensitive stop bumpers located on the front and rear ends of the machine, could only be activated by direct forward or rearward pressure on the bumpers.
  - An object which was positioned laterally, or adjacent to the direct line of travel (as was the case in this incident), would not engage the bumpers and stop the machine.
