# Eco-Safe Means People-Safe

## Sustainability Initiatives & Worker Risk Fatality File

### Worker Killed in Recycling Facility Conveyor System

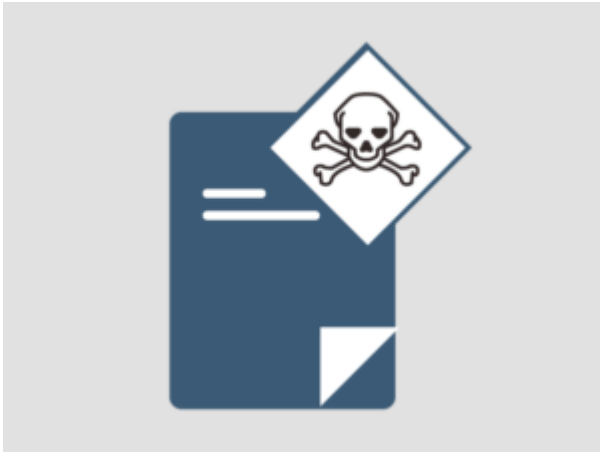
A worker at a recycling facility was assigned to monitor and clear materials from a conveyor system used to sort mixed recyclables. During operations, debris became jammed in the conveyor. Instead of stopping and isolating the system, the worker entered the hazard area to remove the blockage while the equipment was still running. As the worker reached into the conveyor, they became **caught between moving rollers and the conveyor frame**, resulting in **severe crushing injuries**.

Coworkers attempted to stop the system and assist, but the worker had already suffered critical injuries. Emergency services responded, but the worker later died due to the extent of the trauma. Investigations into similar OSHA cases have identified contributing factors such as **failure to apply lockout/tagout procedures, inadequate guarding of moving parts, and unsafe work practices in active recycling systems**. These hazards are especially common in recycling environments, where continuous processing and unpredictable materials increase the risk of sudden incidents.
