# Grinders Fatality File

## Fatality: grinder incident

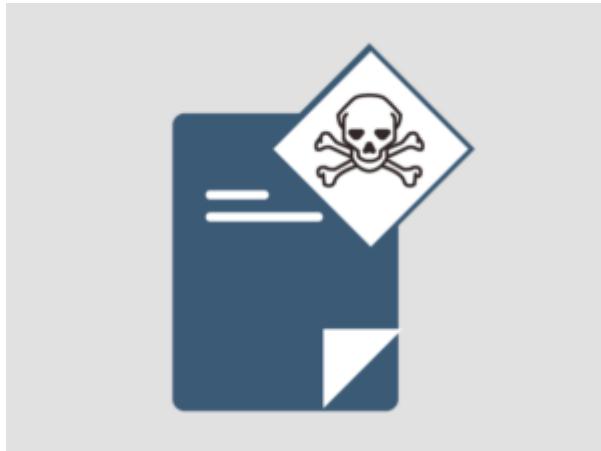
A fatality occurred during preparation of surfaces for welding. A welder was using an angle grinder for the preparation work when the disk of the grinder disintegrated. The hand-held angle grinder was fitted with a 230mm diameter cutting-off wheel, and when it disintegrated, fragments penetrated the victim's chest and abdomen. He was taken to hospital by rescue helicopter but died the same day.

The investigation showed that the angle grinder and cutting disk were not compatible and that the angle grinder had not been fitted with a guard.

The company involved has reiterated that grinding machines should always be used in accordance with manufacturers' instructions, noting in particular that:

- the maximum speed marked on the abrasive wheel should always be greater than the maximum rated speed of the grinder.
- grinding wheels should not exceed the recommended maximum diameter for any given grinding machine.
- worn down wheels from other machines should not be used.
- grinding tools should never be used without the wheel guard attached to the tool and positioned for maximum safety.
- abrasive wheels should be stored and handled with care. They should be inspected for chips and cracks before installation and any apparently damaged wheels taken out of use, marked and stored for inspection/disposed of securely.
