## Is This a Safe Way to Guard a Floor Opening?

What is wrong with this picture?

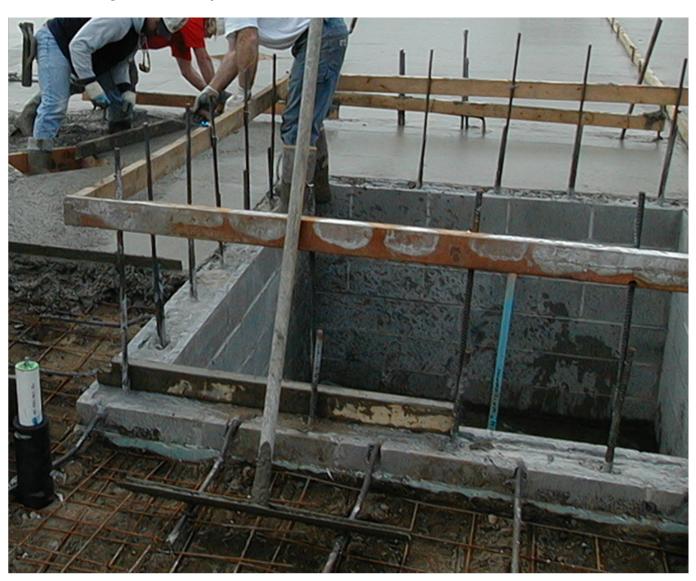
The railing arrangement in this photo is in some ways more dangerous than the floor hole it's guarding:

- There's no intermediate railing; and
- The post ends jutting out from over the top railing are uncapped and could cause serious damage if workers stumble into them.

The railing in this photo is clearly not up to "standard."

**Moral:** Make sure your floor hole guarding arrangements meet OSHA standards and don't expose workers to additional hazards.

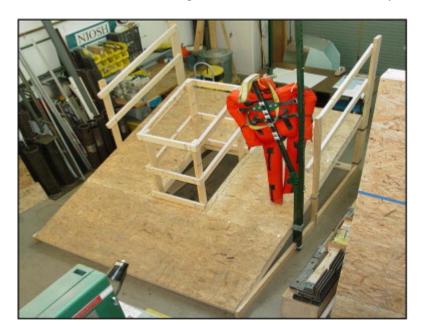
1. A Floor Hole Cover of standard strength and construction;

0R

2. A Standard Railing and Toeboard on all exposed sides.
