## Picture This: Defying the Laws of Physics and Common Sense

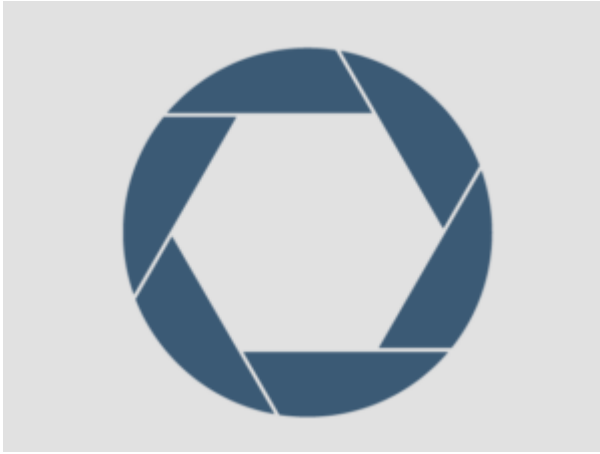
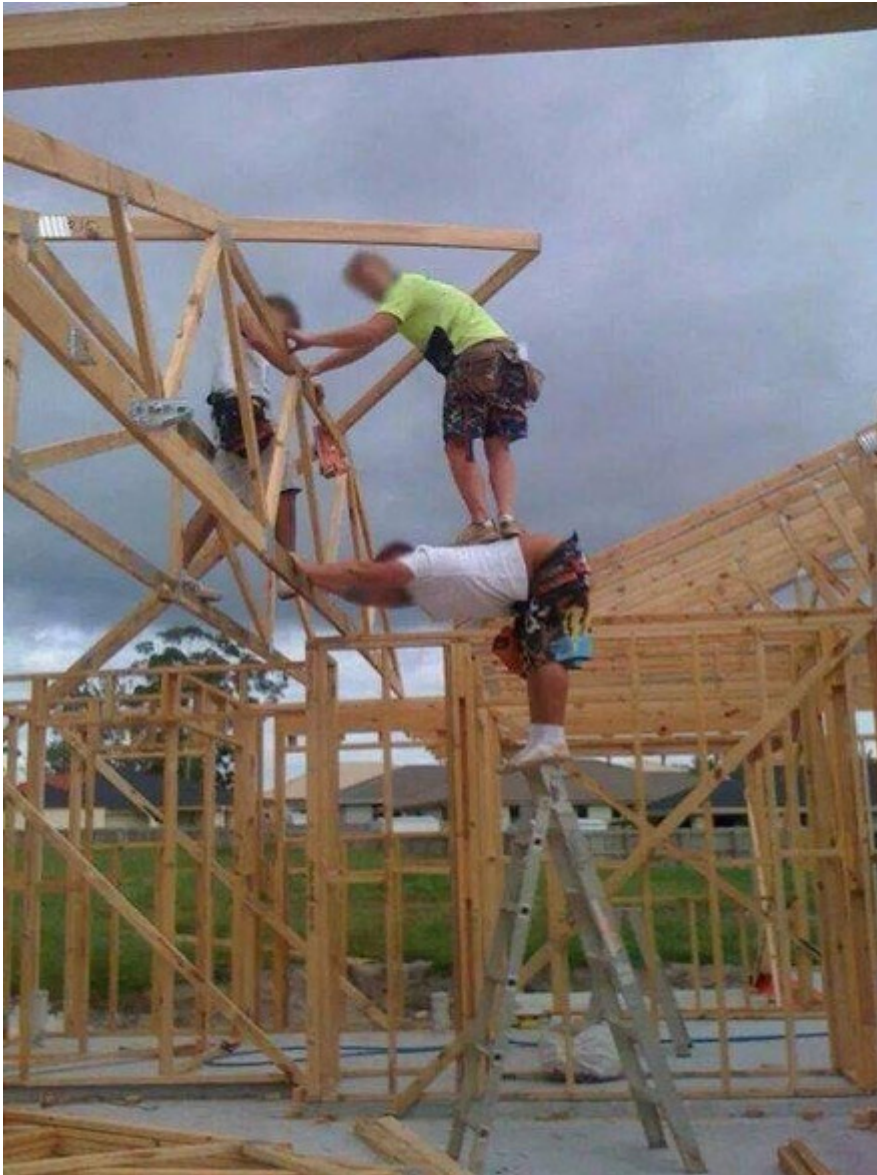
It's almost hard to know where to begin this one – but once the shock and awe wears off, it's obvious there's a lot wrong with this picture.

First, the workers in this picture aren't wearing any sort of PPE. No hard hats, safety glasses, fall protection, or safety shoes, just to state the obvious.

Second, the obvious unsafe use of a ladder. Only one person should be on a ladder at a time. The area around the ladder's base is not cleared of trip and fall hazards. You should never stand on the top two rungs of a stepladder.

Third, while we don't know for sure, it does look a bit stormy in the background. Lightning and other weather-related hazards could very likely be present. If that's the case, these workers should seek shelter immediately or they all three could end up being a lightning rod!
