# Scaffold Safety Picture This

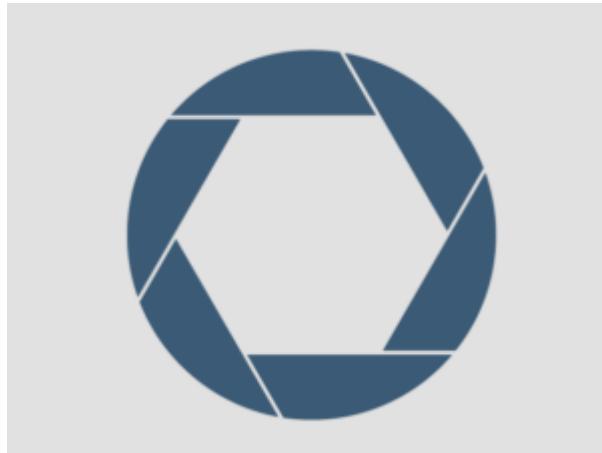
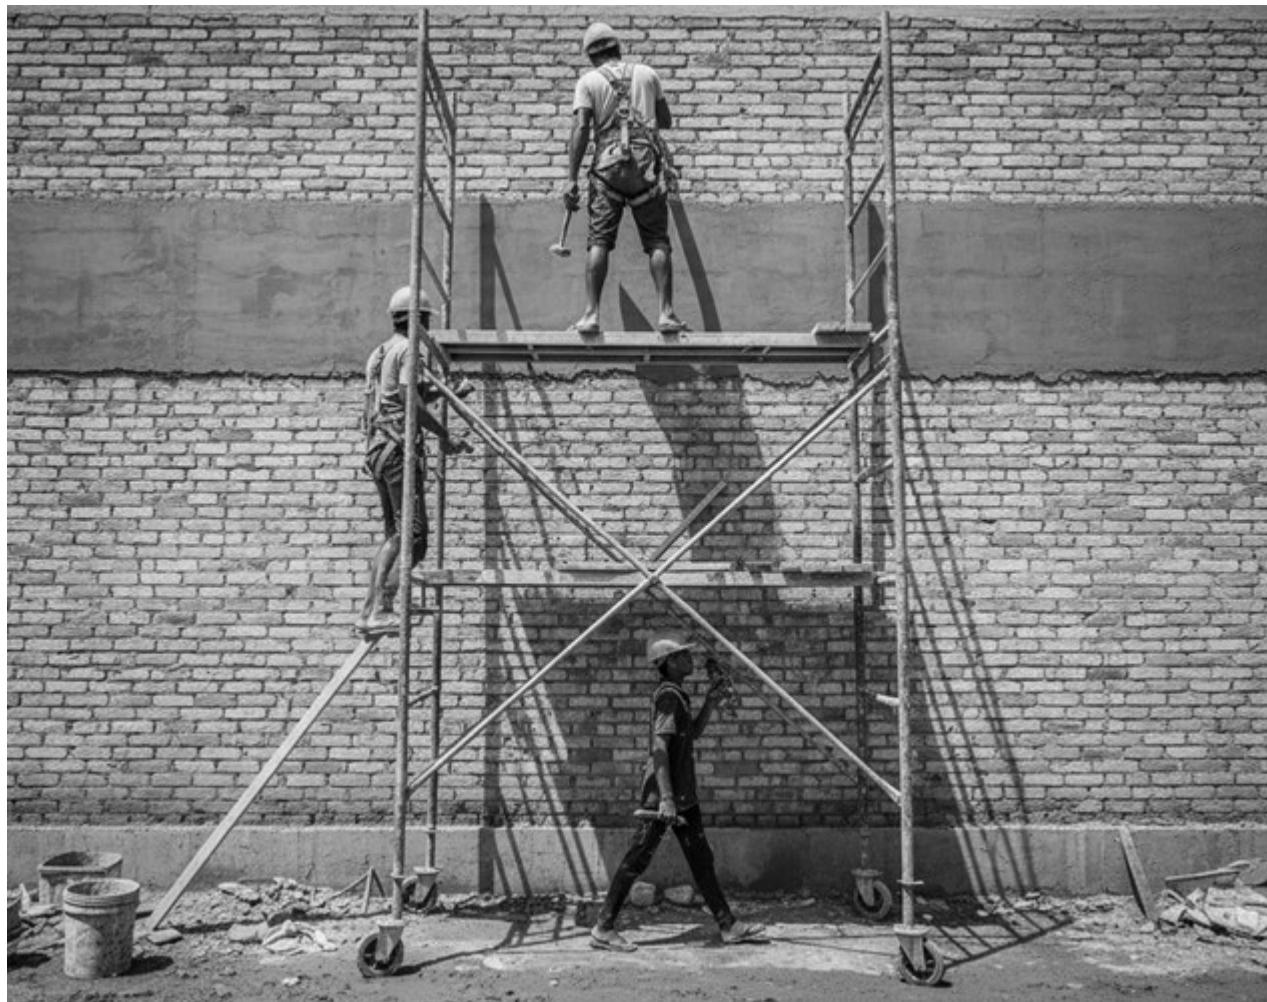
This image captures a highly unsafe scaffolding setup. The base appears unstable, supported by a makeshift wooden plank, and the wheels aren't locked. Workers are climbing the frame instead of using a ladder, and although they wear harnesses, there are no visible anchor points or fall arrest systems in use. One worker walks underneath the scaffold—a major struck-by hazard if tools or materials fall.

Proper scaffold safety requires solid footing, guardrails, safe access, and fall protection. Workers should never climb the frame, work on unstable surfaces, or pass beneath active scaffolds. Regular inspections, proper training, and

adherence to scaffold regulations are critical to prevent fatal falls and injuries. Safety at height starts from the ground up.
