# Scaffold Tower Safety Picture This

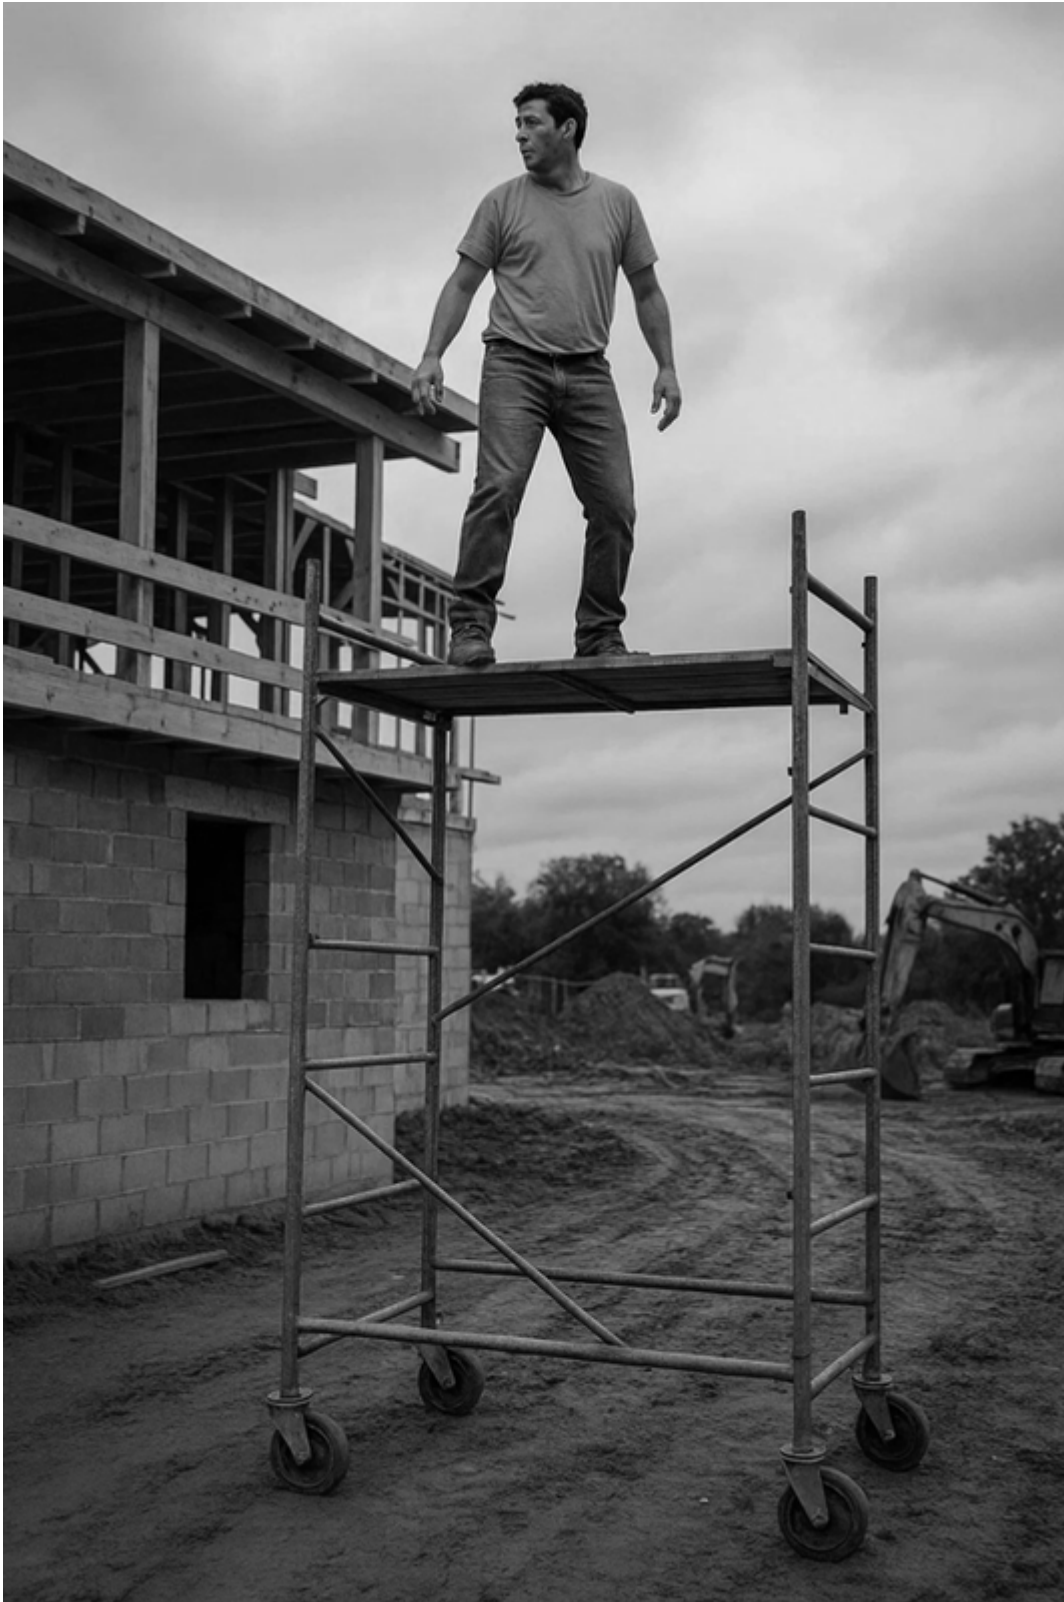
This image highlights a major scaffold tower safety issue. The individual is standing on a scaffold platform without any guardrails, fall protection, or visible stabilization. Additionally, the scaffold has wheels and appears to be unsecured, which increases the risk of movement and collapse. Working at height without proper precautions puts workers at serious risk of injury or death due to falls.

Scaffold towers must be equipped with guardrails, toe boards, and be properly locked in place, especially when used on uneven or soft ground like a construction site. Workers should also use personal fall arrest systems when

required and never climb or work on a scaffold unless it's been inspected and deemed safe. This scenario demonstrates poor planning and non-compliance with basic scaffold safety standards.
