Upper Boom Failure on Aerial Lift

Incident Summary

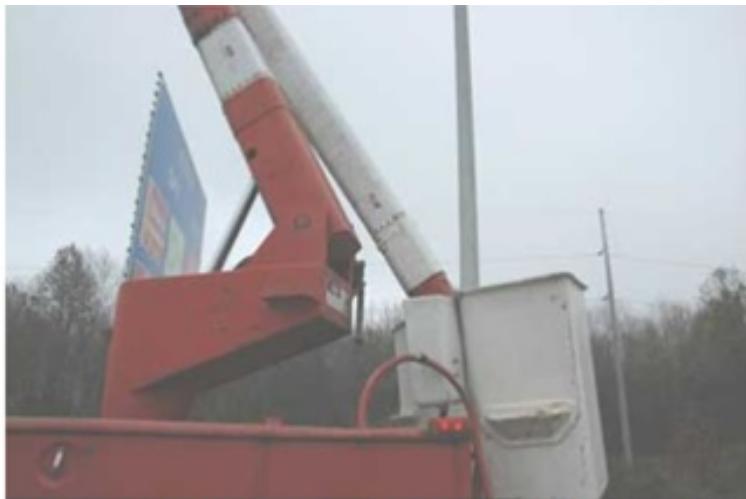
A 45-year-old owner of an electrical contracting company died after falling 9 feet to the road when the articulating boom of the aerial lift truck he was working from collapsed (photo 1).

Photo 1: Aerial lift boom after incident. Note that the lower boom section remains elevated while the bucket-end of upper section is in a lowered position (photo courtesy of OSHA).

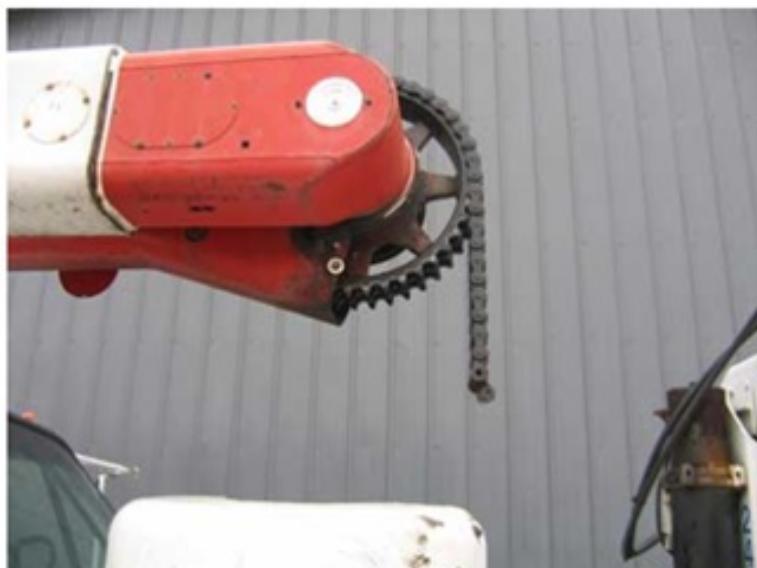
Post incident inspection of the articulating boom revealed the boom actuating chain had separated resulting in the catastrophic collapse of the upper boom (photo 2).

Photo 2: Broken boom actuating chain (photo courtesy of OSHA).

It appears lack of proper lubrication of the chain is likely what caused the chain to break. This incident highlights the significance of:

1. Reading and adhering to the manufacturers' recommended maintenance schedule. The operation and maintenance manual detailed maintenance recommendations, procedures and warnings.
 - In particular, the manufacturer recommended the roller chains, including the upper boom actuating chain, be lubricated every 30 days.
 - A warning in the manual stated a lack of lubrication can cause galling and corrosion of the chain pins; breakage of the pins; and result in free fall of the upper boom (photo 4).

2. Pre-use inspection and removing suspect equipment from service until has been made safe to use.
3. Regular maintenance and inspection by a qualified person.
 - The operation and maintenance manual recommended regular maintenance and inspections to include – the upper boom actuating chain for lack of lubrication, broken rollers and pins.
 - It also stated lack of lubrication is indicated by squeaking or groaning noises when the booms are moved.
 - The recommended inspection/maintenance frequency for pulleys, sprockets, pins and chains is monthly. A major overhaul of the unit was recommended, according to average use, after 3 years or 6,000 hours of use, whichever came first
 - The aerial lift involved in this incident was 18 years old.
 - There was no record of maintenance and inspection having been performed on the boom structure or other assemblies of the aerial lift.

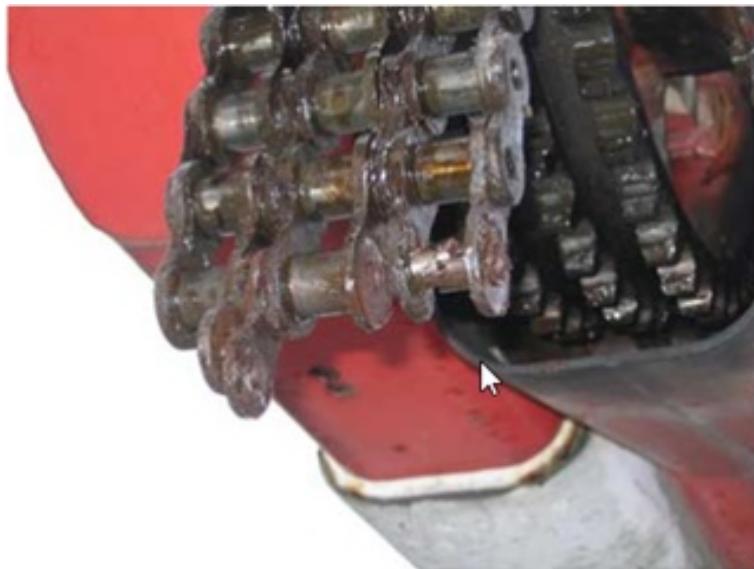
Photo 4: Broken section of boom actuating chain
