# Worker Killed after Entanglement with Rotating Shaft

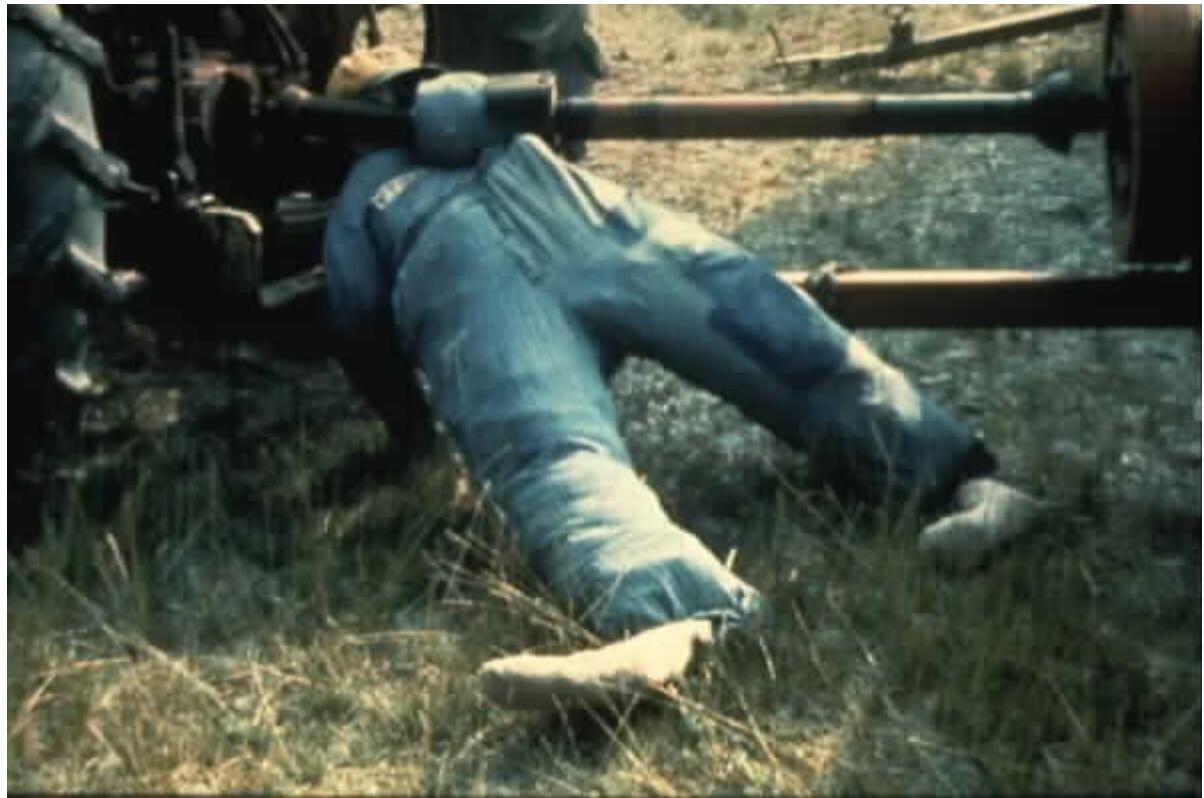
This image shows a pair of coveralls stuffed with straw and demonstrates the power of a rotating PTO shaft and what can happen when loose clothing, the hood on a sweatshirt or coat, or anything else gets up in that rotation. Operating at full speed, the rotating PTO and driveline could wrap 7 FEET of the hood string around the shaft in 1 SECOND!

It's a shocking way to see that the DPW worker didn't have a chance against the force and speed of the PTO.

1. Service equipment following manufacturer's instructions.
2. Only use equipment when manufacturer's guards or an adequate replacement guard is in place and operational.
3. Inspect all safety guards before operating equipment.
4. Never remove machine guards while equipment is energized or can potentially become energized.
5. Never alter machine guards without manufacturer's approval.
6. De-energize and lock-out equipment's energy before removing guard to service equipment and always replace guards after servicing equipment.
7. Don't wear loose clothing or jewelry and keep hair tight.
