Lathes Picture This

What´s wrong in this picture?

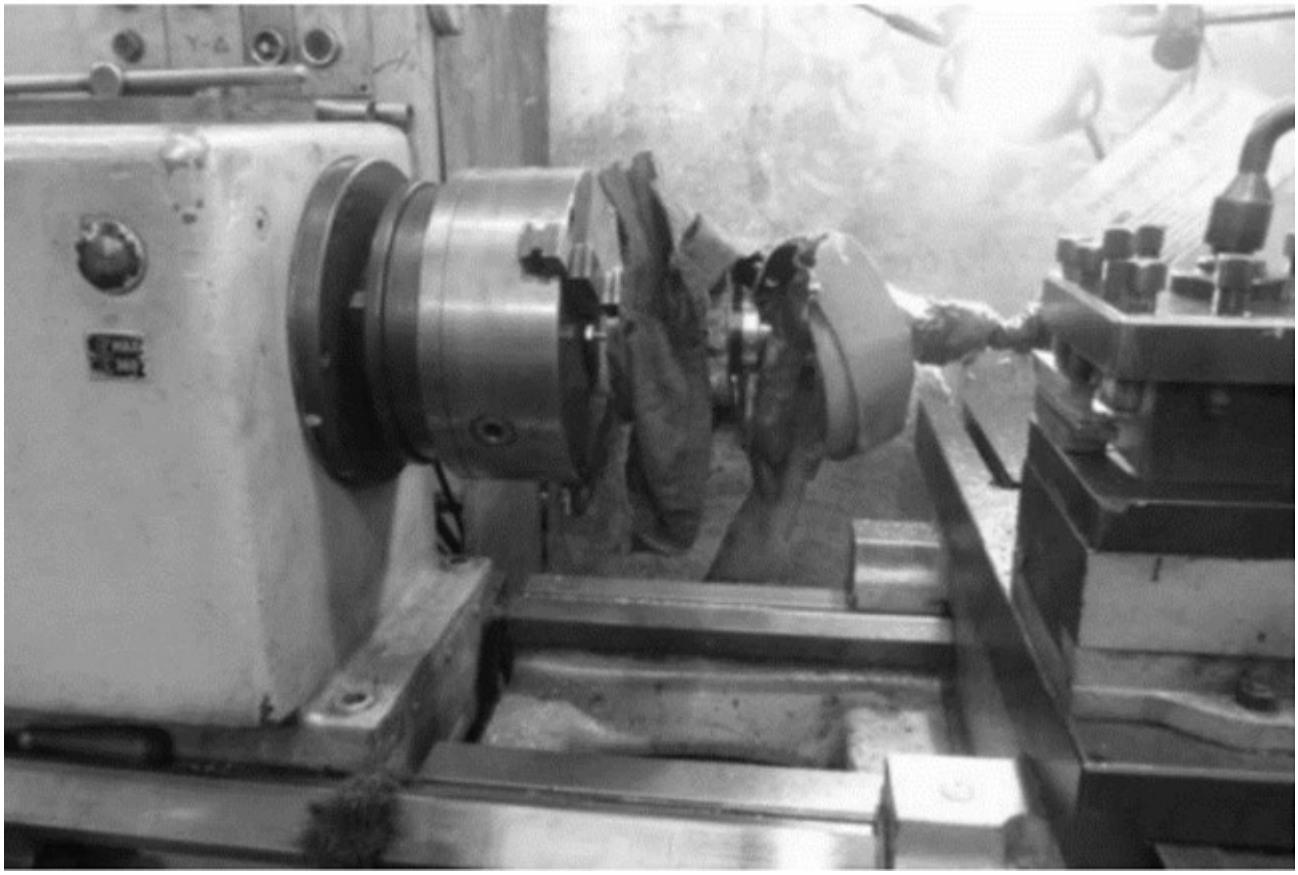
Rotating chuck showing overall sleeve and emery cloth entangled on the spindle. The chuck guard had never been fitted on the lathe. Although no engine ratings witnessed the accident, it was probable that either the emery cloth and / or the loose sleeve of the mechanic´s overalls were caught in the rotating chuck. The mechanic was then pulled over and held down over the rotating chuck, outside the reach of the emergency stop button.

In addition, the lack of a physical barrier around the chuck, the lathe had another design problem with the position of the emergency button, which was not within reach of the trapped and injured operator.

entanglement hazards. Keep all body parts away from all rotating parts. Never wear loose-fitting clothing or jewelry while operating a lathe.

So it is important to keep your hands and fingers away from any moving parts or cutting tools. Avoid reaching across the rotating chuck or work piece when you are filing or burnishing. Never use your hand to stop a moving chuck. Instead, move the cutting tool away from the metal, turn off the lathe and remove the work piece.
