Warehouse Supervisor Crushed by Pallet Stacking Machine

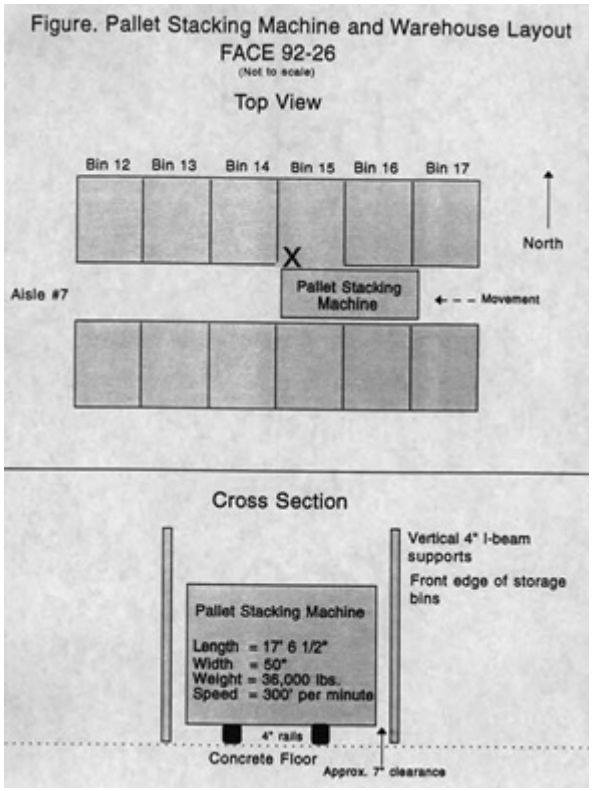
Victim

A 40-year-old experienced warehouse supervisor died when he was struck by a pallet stacking machine and crushed against a storage rack support.
