# Mooring Safety – Small Vessels Fatality File

## Crew Member Dies During Mooring Operation

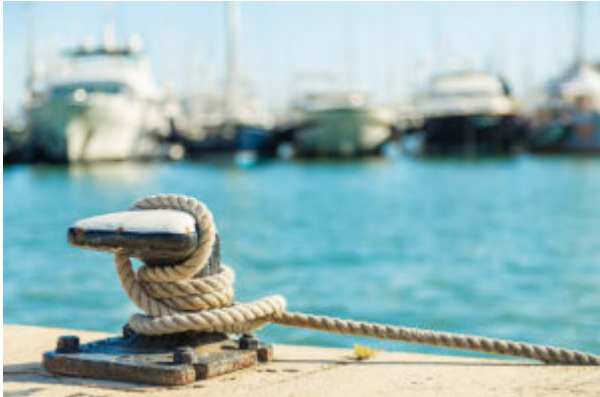
In order to attach the aft towline, the ship's messenger line was lowered through the aft centerline Panama fairlead to the tug. The mate of the tug received the line and tied it to the tug's messenger line, which was attached, in turn, to the steel tow wire. The aft mooring team on the cargo vessel took up the slack in the messenger lines and attempted to heave up the tow wire by hand.

The carpenter had taken approximately eight to ten turns of the thick messenger line around the drum. These turns accumulated towards the outboard end of the drum as it rotated due to the angle of the lead from the pedestal fairlead. The free end of the messenger line then became entangled in "riding turns", causing it to be heaved back into the warping drum with the part under tension. As this was happening, the tow wire came up onto the cargo vessel's deck and the towing eye nearly reached the aft bitt.

As heaving continued, the messenger line slipped off the side of the warping drum, causing the tow wire to drop back down towards the tug. This re-occurred on several attempts until at one point, when the carpenter was standing with his head a few centimetres away from the drum, he was heard to cry out. The second officer stopped the winch and quickly moved around to the drum end. There, the carpenter was found slumped forward on the messenger line with a loop of rope hanging loosely around his neck. After medical attention at the port, the victim was declared dead due to a fracture dislocation of the cervical spine.
