# Fall Through Temporary Roof Opening

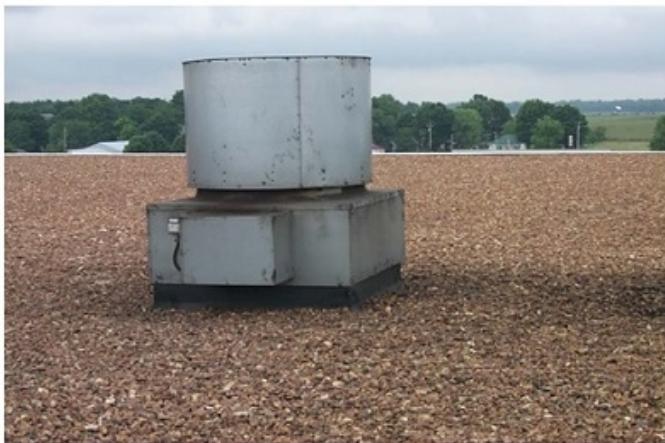
**Exhaust fan had been removed for cleaning, creating a temporary opening where cleaner fell approximately 35 feet/10 meters onto a piece of machinery in the factory.**

A 50-year-old male cleaner died when he fell approximately 35 feet through a temporary roof opening and was impaled on a piece of equipment on the factory floor below. He had been cleaning an exhaust fan with a pressure washer on the factory roof. He and two co-workers had removed the fan from its casing creating a temporary roof opening and set the fan beside the roof opening for cleaning.

Facing the fan with his back to the opening, the cleaner apparently stepped backwards and fell through the opening.

1. Openings in roofs, floors, and walls must be barricaded, protected with a guardrail system, or covered with marked covers to prevent someone from unintentionally falling through them.

- a. The employer stated that the factory initially did not want the holes covered up when the fans were removed because it would keep air from flowing out of the factory.

- b. After this incident occurred, the company constructed covers of 2 x 4s and plywood nailed together to be placed over the temporary holes in the roof while the fans were removed.

- c. Additionally, a moveable four-wall, five-foot-high barricade could have been constructed for the roof openings. This would have allowed the factory air to exhaust through the roof openings while the fans were being cleaned.

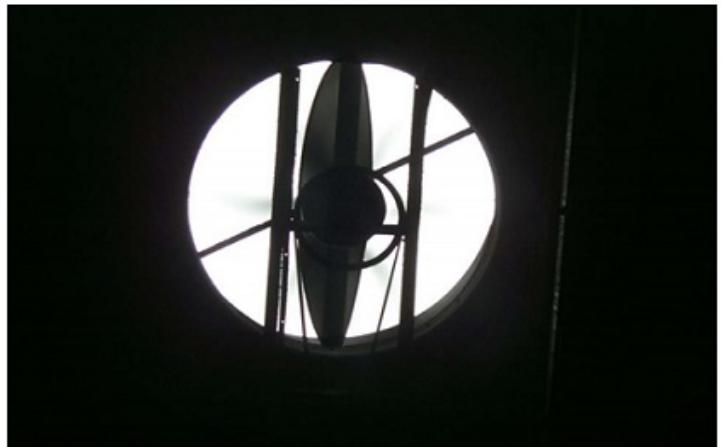
**Exhaust fan above machinery on factory floor.**

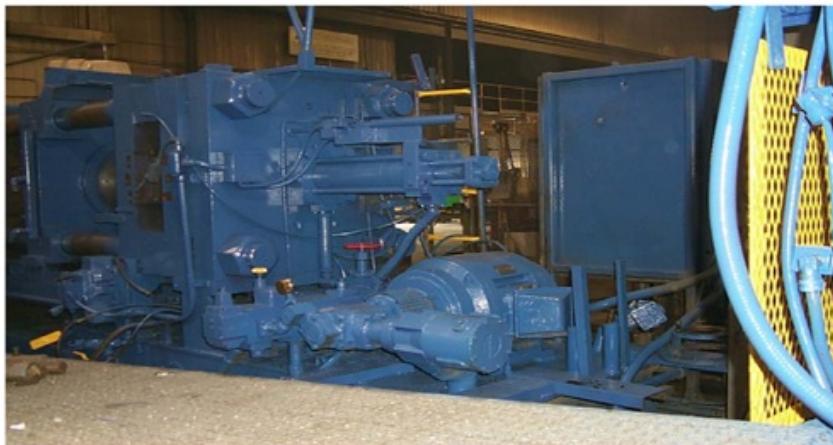
He fell onto a 1200-ton die-casting machine on the factory floor. Onsite personnel working nearby heard the cleaner fall onto the machine. They summoned

**Machinery victim fell on.**
