# Aerial and Scissor Lifts – Landscaping Fatality File

## Fatal Aerial Lift Accident During Tree Trimming

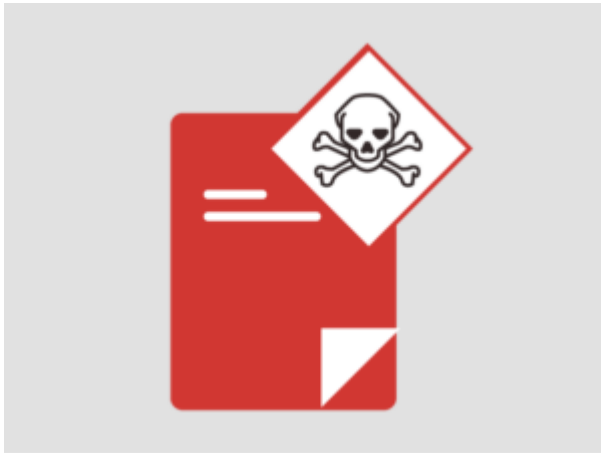
On August 12, 2023, a fatal accident involving an aerial lift occurred during a tree trimming operation in a residential neighborhood in Orlando, Florida. The incident resulted in the death of a 39-year-old landscaping worker, Jonathan Reed. Reed was operating a scissor lift to reach and trim high branches when the lift suddenly tipped over due to unstable ground conditions.

Despite being harnessed, Reed was ejected from the lift when it fell and suffered fatal injuries upon impact with the ground. The investigation revealed that the lift was not properly stabilized, and no thorough inspection of the ground conditions was conducted prior to use. Additionally, the lift was being operated near power lines, increasing the risk of electrocution, which fortunately did not occur in this instance.

In response to this tragic incident, the landscaping company has implemented stricter safety protocols, including mandatory ground stability checks, proper use of outrigger stabilizers, and comprehensive training for all operators of aerial and scissor lifts. The company also introduced regular maintenance and inspection schedules for all lifting equipment to prevent future accidents.
