# Beams Fall on Trucker

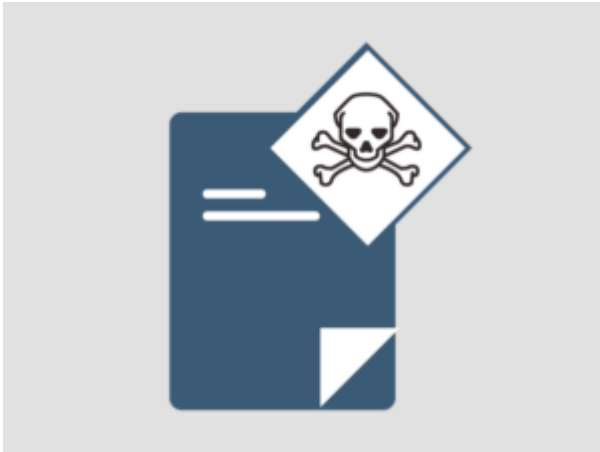
A truck driver was killed by a 750-pound (340-kilogram) package of beams which fell from a forklift.

Four 34-foot long (10-meter) laminated beams banded together were being added to a flatbed trailer, already partially loaded. The load had no spacer boards on top, so the forklift mast had to be tipped to slide the banded beams off. The victim stood on the rear of the trailer, guiding the beams. They were dipping at their ends. One end slid off first. Its impact caused the beams to bounce and swing toward the victim, striking him. He fell off the trailer and his head was crushed by the falling beams.

**Investigators called for enforcement of a standard forklift loading procedure and recommended:**

- Only safely arranged loads be handled.
- Spacers placed between loads or units.
- No spotter stands near a moving load.
- The spotter/helper be kept in the operator's sight.
