Electrical Hazards in Construction – Power Tools Picture This

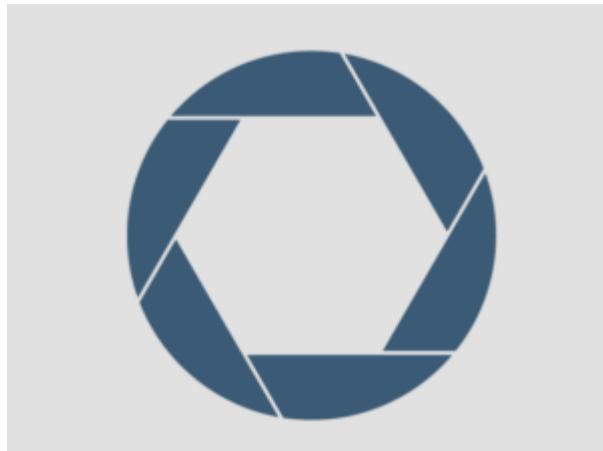
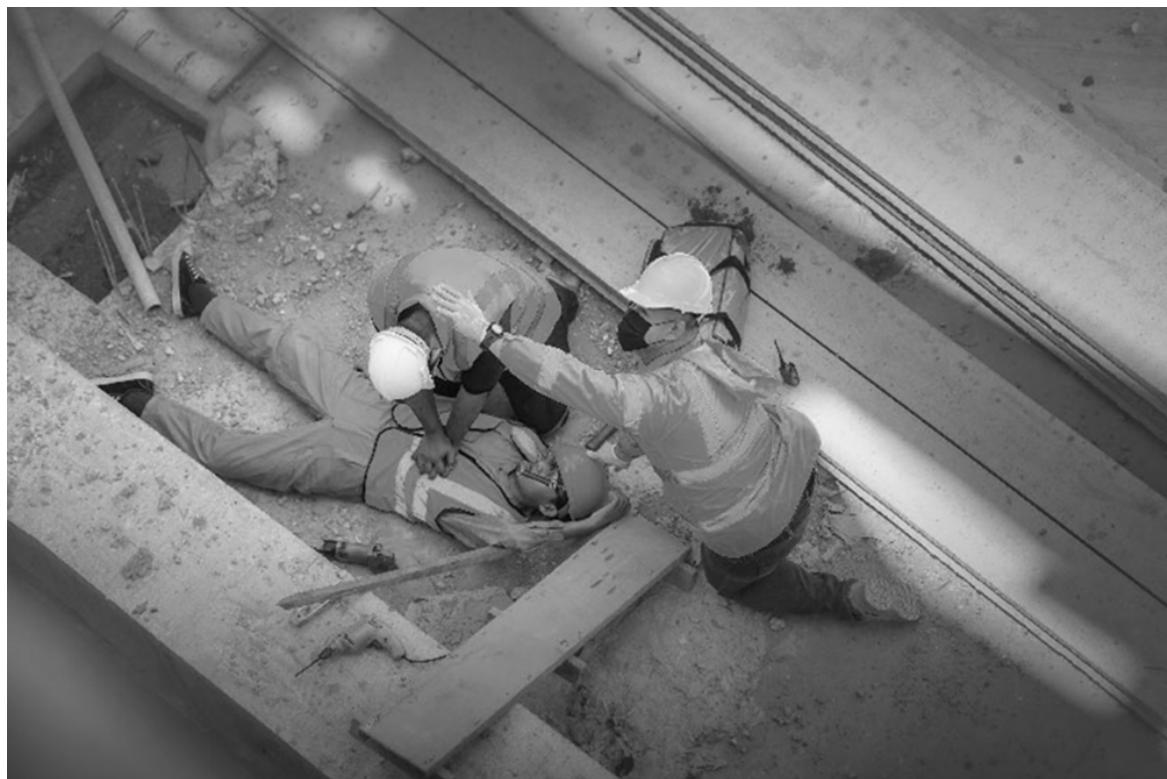
The worker is lying injured on a concrete surface, likely due to an electrical shock or fall related to unsafe tool use or exposed power sources. Tools are scattered on the ground and no barrier or warning signage is visible, indicating poor housekeeping and hazard control. There's no sign of ground fault circuit interrupters (GFCIs) or protective measures to prevent such incidents.

Ensure all electrical tools are properly maintained, grounded, and connected to GFCIs in wet or unfinished environments. Keep the workspace clear of obstructions, and use signage or barriers around hazardous areas. Provide thorough training in electrical safety procedures and emergency response to reduce injury risks.
