Half-Safe Setup Claims Worker

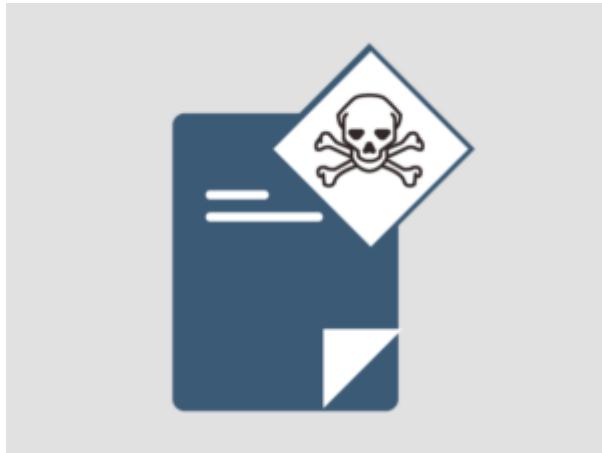
Electrical lines were grounded and de-energized before a lineman went to work on them, but he still died of electrocution.

He was working from an aerial lift with an articulated boom. The basket touched energized lines located beneath the de-energized lines. An insulation defect in the lift basket allowed current to pass through the body of the basket and through the employee, then to the ground by way of a de-energized line.

Investigators looking into this fatality found barriers should have been put up to avoid contact with energized lines. As well, there should have been a thorough assessment of the work conditions, including mechanical equipment such as the lift, energized electrical equipment, poles and location of lines. In other words, lack of supervision allowed these precautions to be ignored.

To prevent fatalities like this, employees must be instructed how to recognize and avoid unsafe conditions and they must know regulations applying to a particular work environment. The job safety breakdown should involve all workers associated with the job to be done.
