Mobile Elevated Work Platforms (MEWPs) Picture This

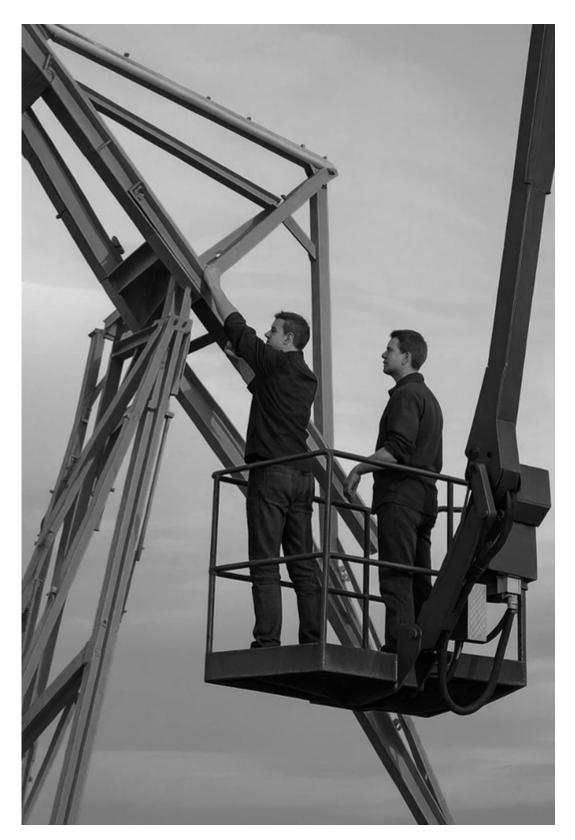
This image shows two workers on a mobile elevated work platform (MEWP), but several safety concerns are visible. Neither worker is wearing a safety harness or fall arrest system, which is essential when working at height on MEWPs. Additionally, they appear to be standing very close to the edge without proper anchorage or protection.

Operators of MEWPs must always wear the appropriate personal protective equipment (PPE), including a full-body harness attached to a designated anchor point. They should also ensure the platform is stable, inspected, and used only on firm ground. This image underscores the importance of fall protection and

pre-operation safety checks to prevent potentially fatal accidents.
