# Picture This! A Bucket Load of Problems

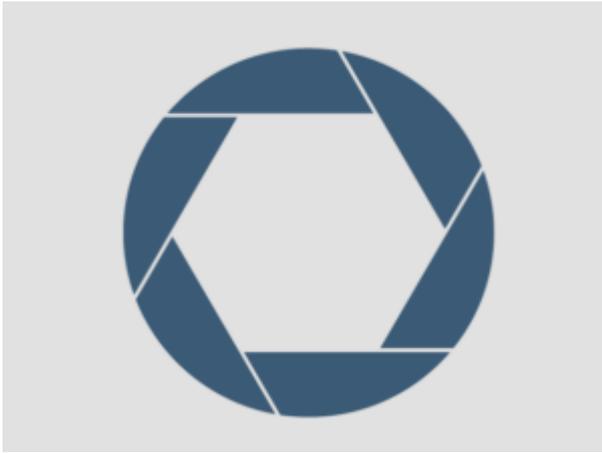
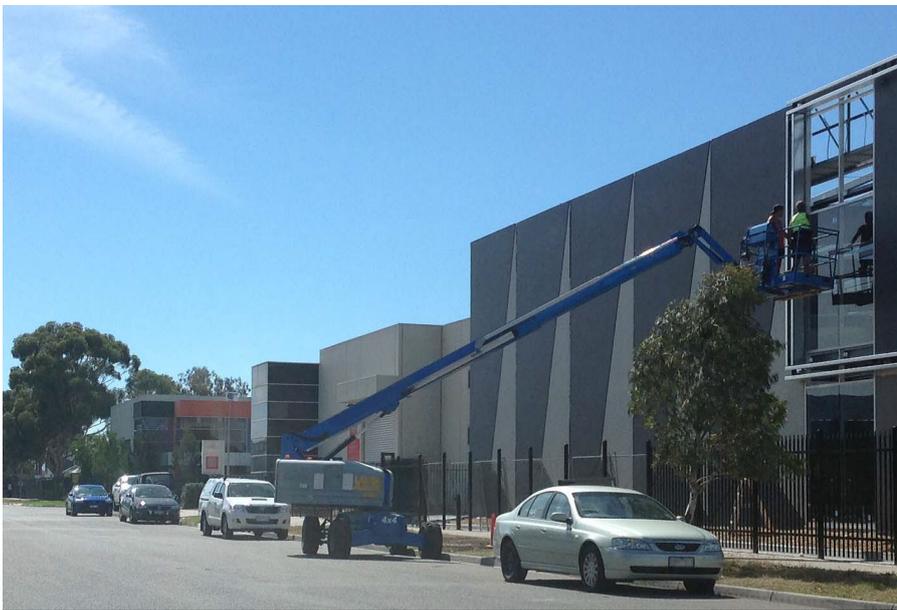
What's wrong with this picture? Actually, there are three things. First, the workers in the bucket are not wearing fall protection harnesses. Second, the counterweight on the lift is protruding into a traffic lane, with no traffic management practices in place, and third, there is no barricade to prevent people from walking under the boom or bucket. (Victorian WorkCover Authority, Australia)
