Two Lone Worker Deaths in 24 Hours

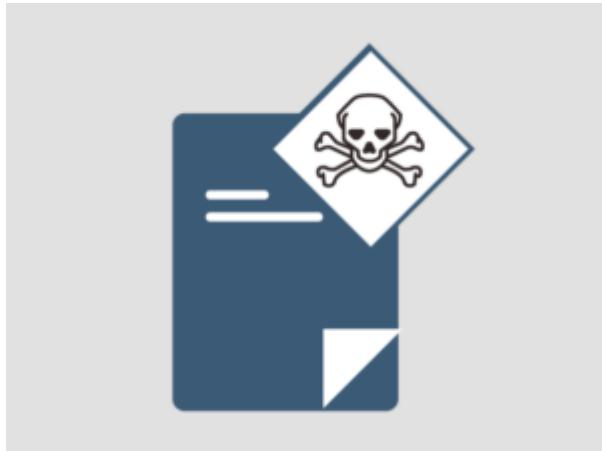
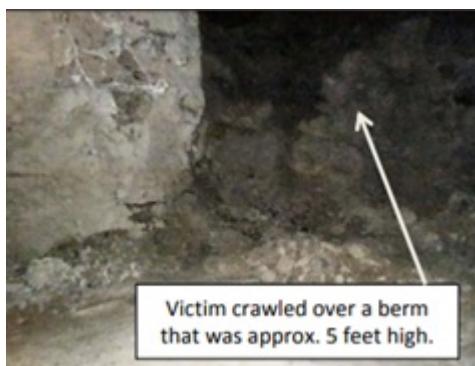
On January 25, 2017, a miner was found in an underground limestone mine after failing to exit the mine at the end of his shift. The miner was found under material that had fallen on him from a rib in an area of the mine that had been barricaded to prevent entry due to bad roof and rib conditions.

1. Never enter hazardous areas that have been barricaded or otherwise identified as unsafe to enter.
2. Develop and train workers on a method that clearly alerts them not to enter hazardous areas. Enforce this with disciplinary action if protocol/area is breached.
3. When possible, do not let workers work alone, especially in hazardous areas. If work must be done solo, set up a plan for communication.

4. Before any solo work is done identify known and potential hazards.
5. Never perform work on a moving conveyor belt or other moving equipment or machinery.
6. Never perform work on any machine, equipment, or vehicle without taking following LOTO procedures – de-energize electrical power, lock and tag the disconnect with your lock and tag, and block parts that can move against motion.

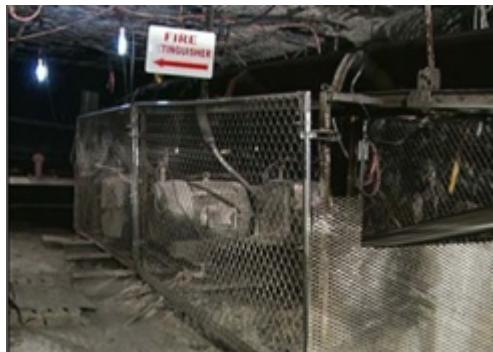
On January 26, 2017, a coal miner was discovered entangled at a conveyor belt drive, also after failing to exit the mine at the end of his shift. In both instances the victims were working alone and in restricted areas where there were hazardous conditions.
