# Verifying Safeguards Picture This

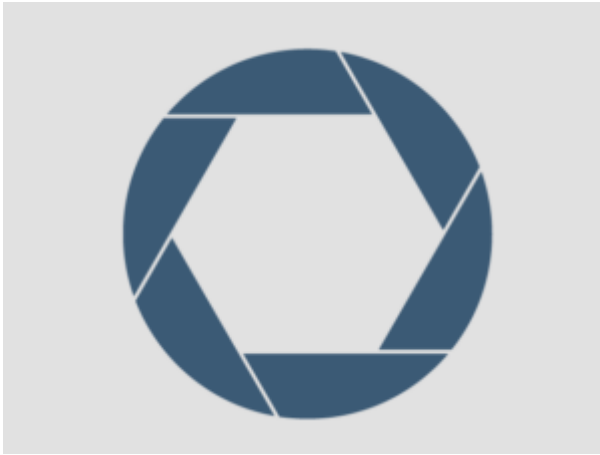
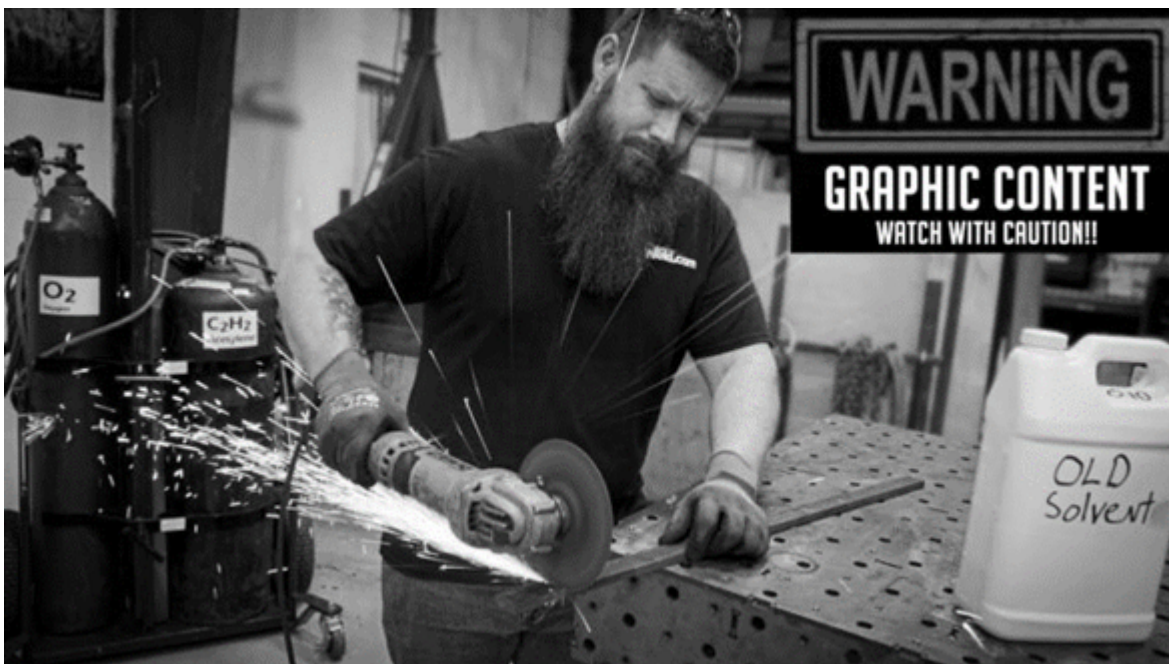
**What is wrong in this picture?** There is a man doing multiple unsafe procedures in this picture, first he is using a grinding wheel without any guard, second all the sparks coming out of the machine are falling into two oxygen cylinders which makes it too dangerous, third he is not wearing any facial mask or glasses to protect his eyes from those sparks and finally there is a solvent jug close to his work area. All of those unsafe procedures are strongly dangerous that can result in a horrible disaster with many injuries, burns and even death.

Never use a machine without the guard which is provided for protection. Check the machine for any kind of crack or damage before using the grinder.

Never use a machine without wearing all the personal protective equipment and clothing such as goggles, helmets, masks, ear protection, gloves, leather aprons etc. Also ensure that the personal protective equipment and tools are in proper condition before using them.

Finally, make sure all safeguards are in place to avoid a catastrophe, check your work area before starting working, follow all safety work practices and ensure your personal safety.
