# Welder Dies in Tanker Trailer

A 37-year-old welder died when an explosion occurred in the tanker trailer where he was working.

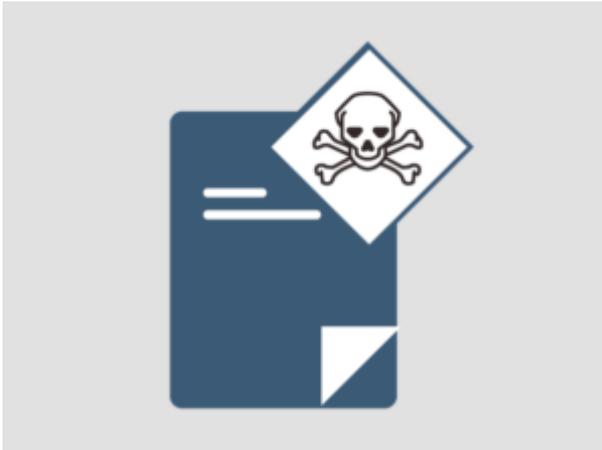
The victim, a welding contractor who worked for a trucking company, had been asked to repair the bulkhead of a petroleum tanker trailer.

According to co-workers, the tanker trailer had been “blown out” (a process used to rid tankers of excess petroleum vapors) several days prior to the incident. It is not known whether the victim had performed any air sampling before beginning work on the day of the incident. An explosion occurred shortly after the victim began welding. The victim’s employee, who was on top of the tanker at the time, left the scene shortly after the incident occurred. Police were the first to arrive. One officer went inside the tanker trailer to check on the victim. He reported the welder had been killed during the explosion. The victim was not removed from the tanker trailer until approximately seven hours after the incident because the fire department was concerned about another potential explosion.

- Maintain a written injury and illness prevention program.
- Initiate a comprehensive enforcement and safety review program for confined space entry procedures.
- Expand confined space policies to address hazards due to oxygen deficient, flammable/explosive or toxic environments.
